Manhole Inspection Summary

Manhole # S33KK_003MH

Insp Date: **12/6/06 2:25 PM**

Location Address: **1904 CHARLES ST**

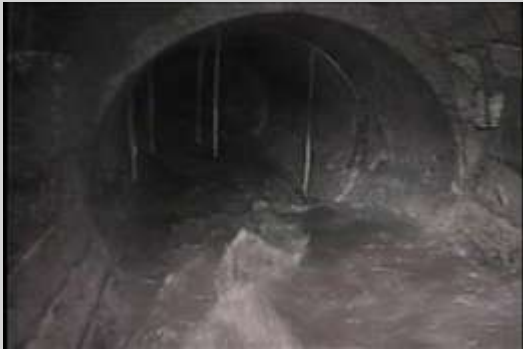
21 in. Circular Gravity Sewer Pipe Out @ 12 O'Clock

Invert Depth: **11.00** (ft.) Flow Characteristics: **Fast**

Deposits: ☒ None ☐ **Mud** ☐ Sludge ☐ Debris ☐ **Grease**

Infiltration: **None** Pipe Seal Cond: **Unknown**

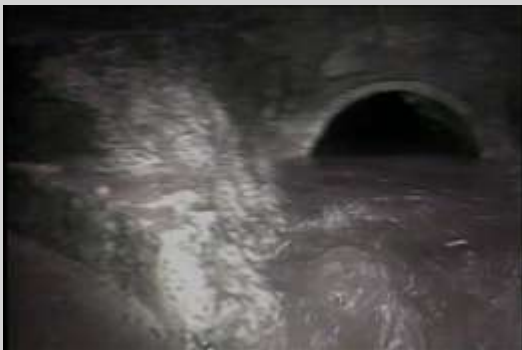
18 in. Circular Gravity Sewer

Infiltration: **None** Pipe Seal Cond: **Unknown**
